## Historic District Review Committee

### Staff Report July 13, 2009

**CAPP 2009-0009 Bluemont Community Center: Renovation and Rear Addition in the Bluemont Historic District. MCPI 632-15-4042.**

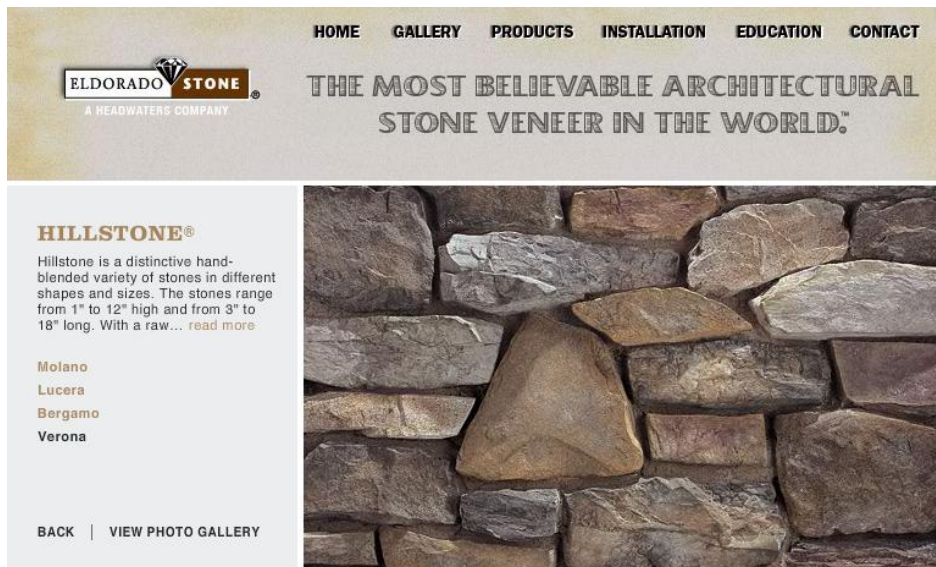
**Photo 1:** Detail of proposed stone veneer, Eldorado Stone: Verona Hillshade. Source: <http://www.eldoradostone.com/flashsite/>

The foundation for the addition will be concrete with an imitation stone veneer. It will match the height of the stone foundation on the existing historic building. The proposed stone veneer will be manufactured by Eldorado and Verona Hillstone with "over-grout" is proposed (Photos 1 and 2). Distinguishing the foundation from the rest of the building meets the ABOT Guidelines for new construction. Cladding the foundation with an approved stone veneer on all elevations of the addition also meets the guidelines. The proposed stone veneer appears to be similar to the color, texture, shapes, and sizes of the existing stone foundation (Photo 3). Staff requests that the applicant bring a sample of the product to the HDRC meeting to evaluate whether the proposed veneer is an appropriate substitute material (ABOT Guidelines, Guidelines for New Construction: Foundation, Guidelines 1-4, and 6, pg. 77; Guidelines for Materials: Stone and Brick, Guideline 7, pg. 129).

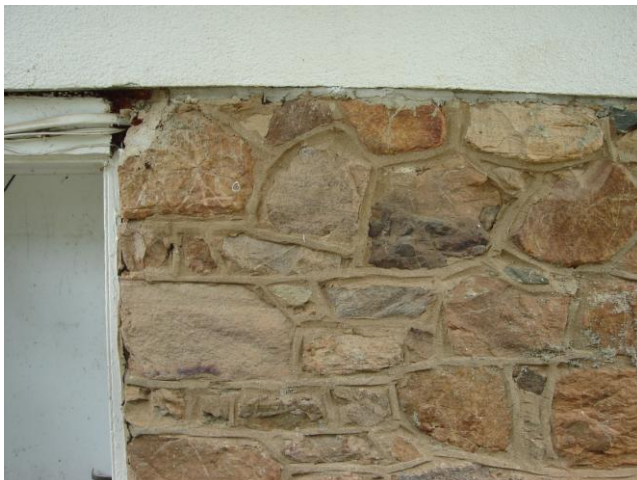
**Photo 3:** Existing foundation stone on the Bluemont Community Center.

The mortar should match the color, material, texture, joint size, and tooling of the historic building mortar (ABOT Guidelines, Guidelines for Materials: Stone and Brick, Guideline 2, pg. 129). The existing mortar has a tooled, flat bead joint. "Over-grout" is the proposed mortar joint, which will be tooled by masons to match the existing mortar joints. Additionally, the mortar will match the color, and texture of the existing foundation mortar.
